Inspection Report

Permit Number:	C0070012
Inspection Type:	PARTIAL
Inspection Date:	Tuesday, November 30, 2004
Start Date/Time:	11/30/2004 9:00:00 AM
End Date/Time:	11/30/2004 12:30:00 PM
Last Inspection:	Wednesday, October 27, 2004

Permitee: **NEVADA ELECTRIC INVESTMENT CO**

Site: **WELLINGTON PREPARATION PLANT**

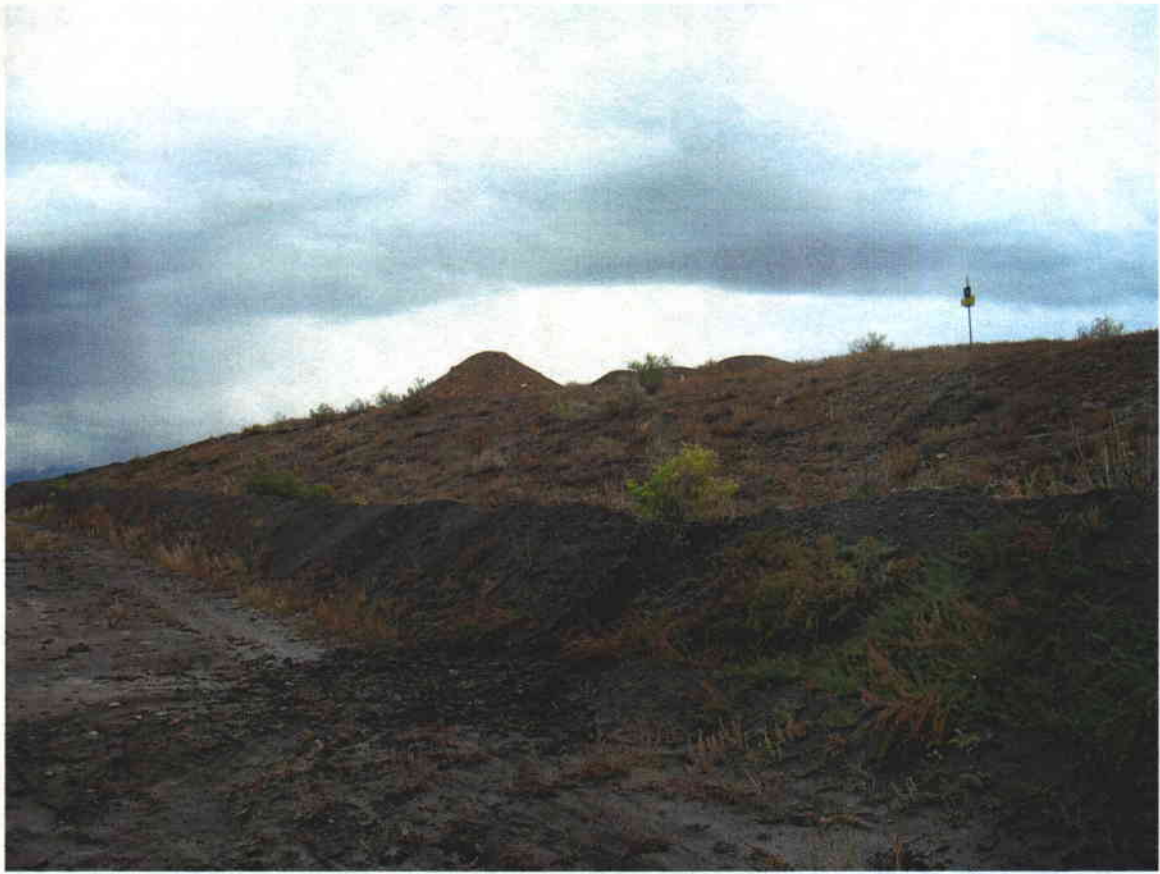
Topsoils were inspected for stability and interim vegetation establishment. The two topsoil piles were found to be stable and have full containment. The breach in the topsoil pile berm located adjacent to the Siaperas ditch was repaired adequately. Photo M:\FILES\COAL\PERMITS\007\0012\IMAGES\11302004\DSCN0335 illustrates the repair. With the light snow cover, the repair appears seamless.

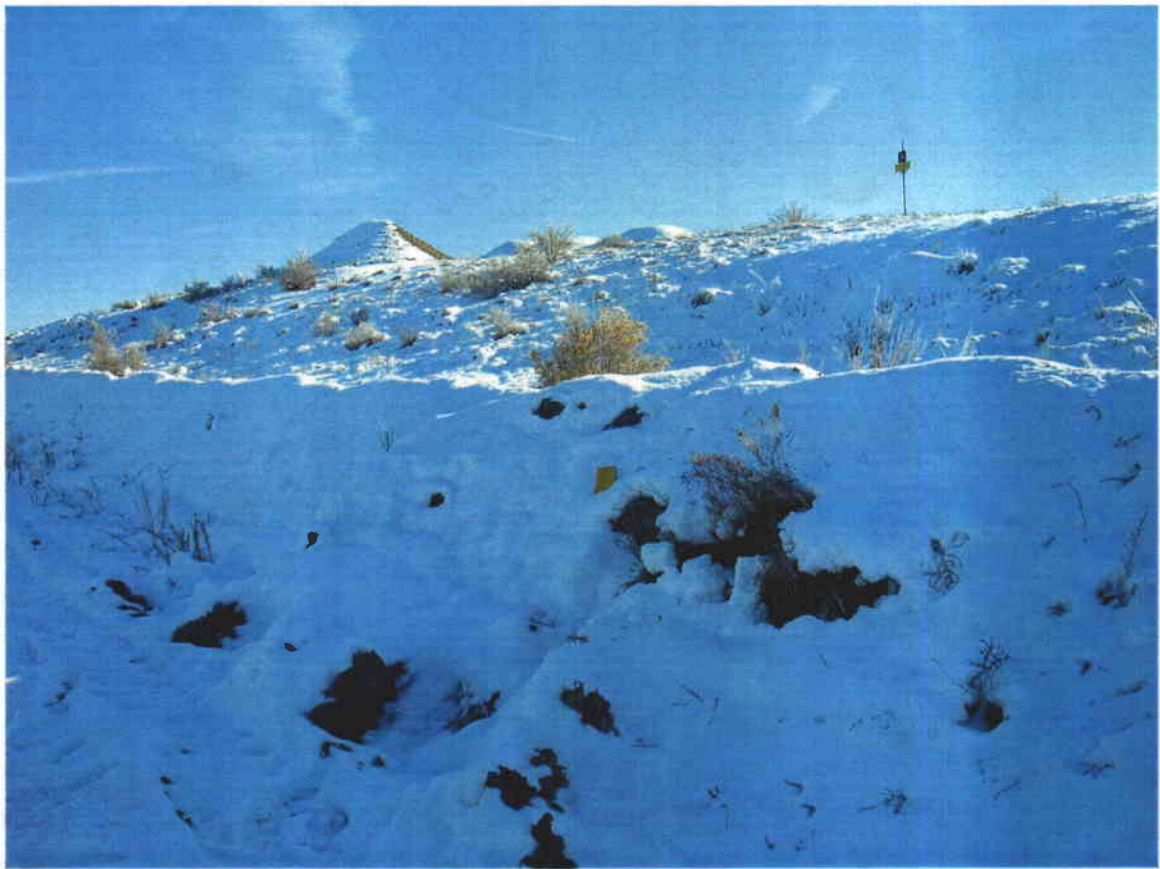
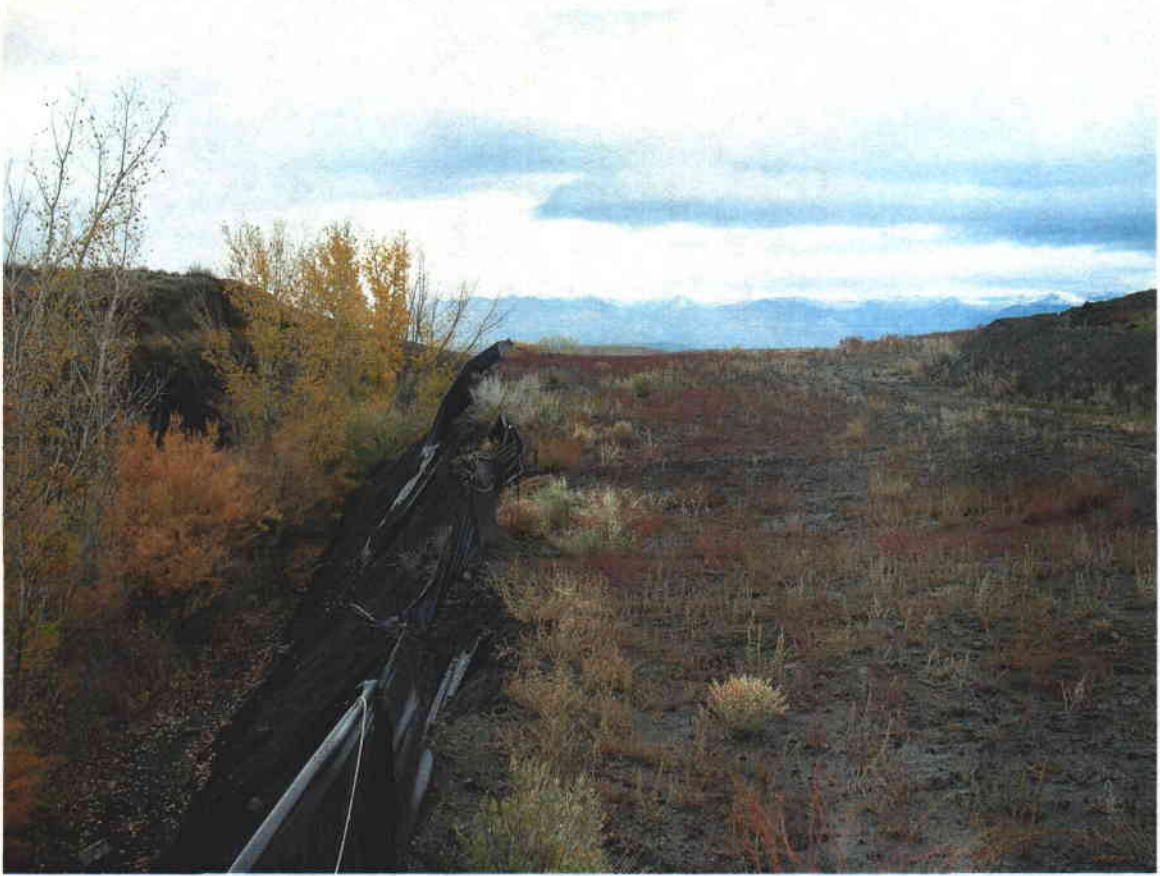
Repairs to the silt fencing located adjacent to the Siaperas ditch that was described last month was repaired since the last inspection. Photos M:\FILES\COAL\PERMITS\007\0012\IMAGES\10272004\DSCN0277 and M:\FILES\COAL\PERMITS\007\0012\IMAGES\11302004\DSCN0336 illustrate before and after photos of the repairs that were conducted. No additional repairs are necessary at this time.

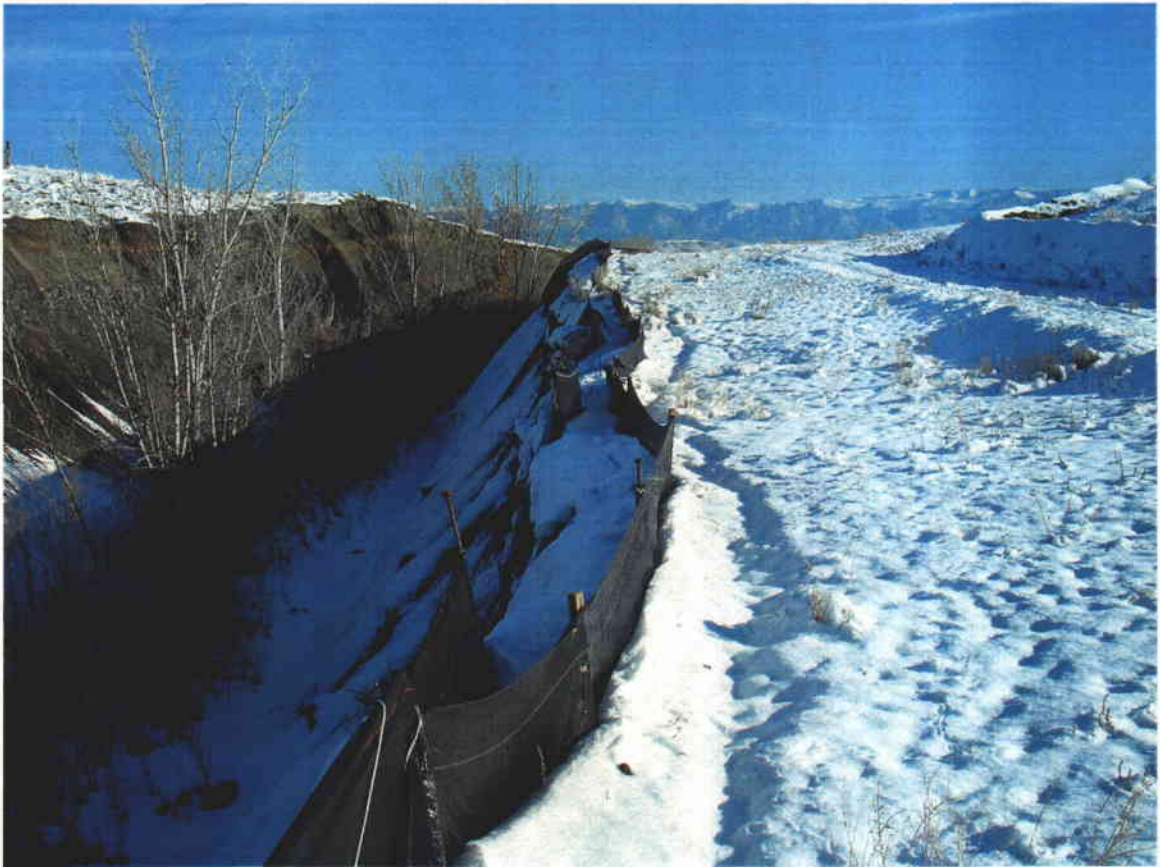
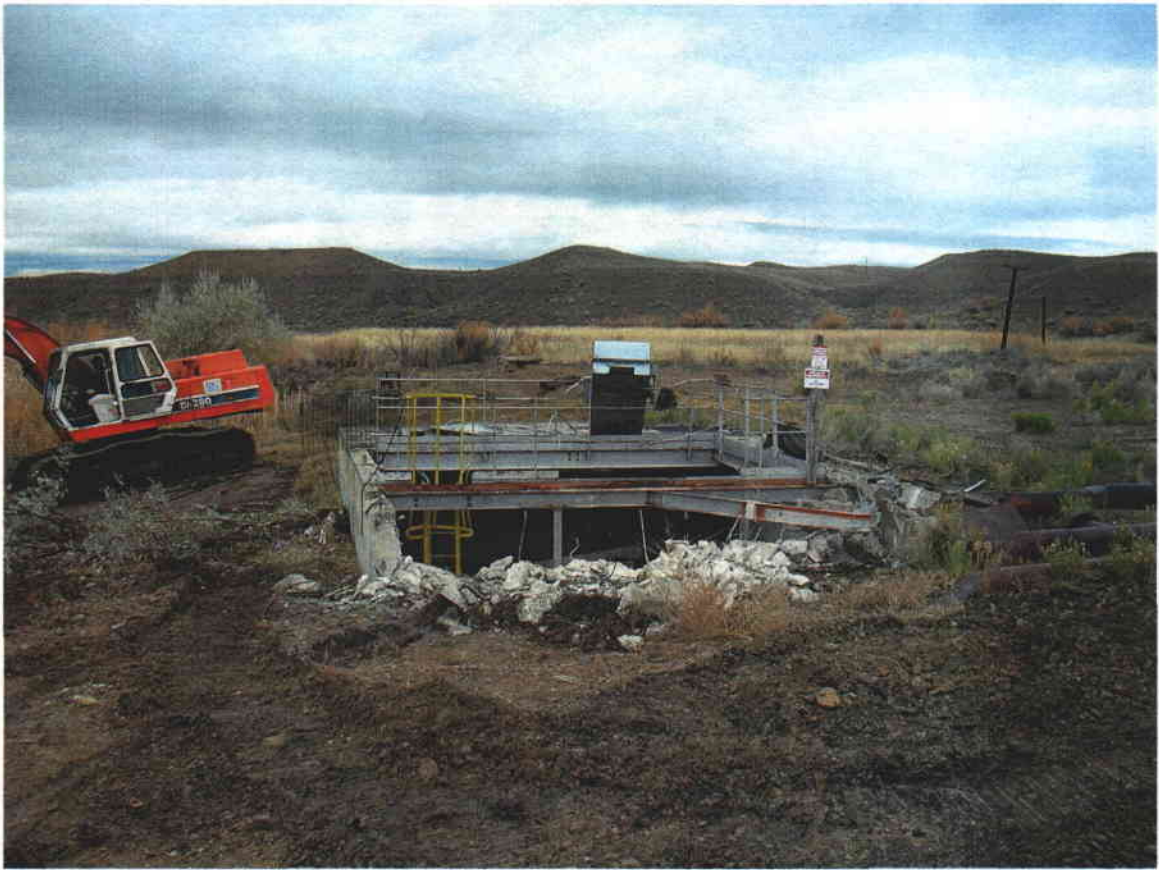
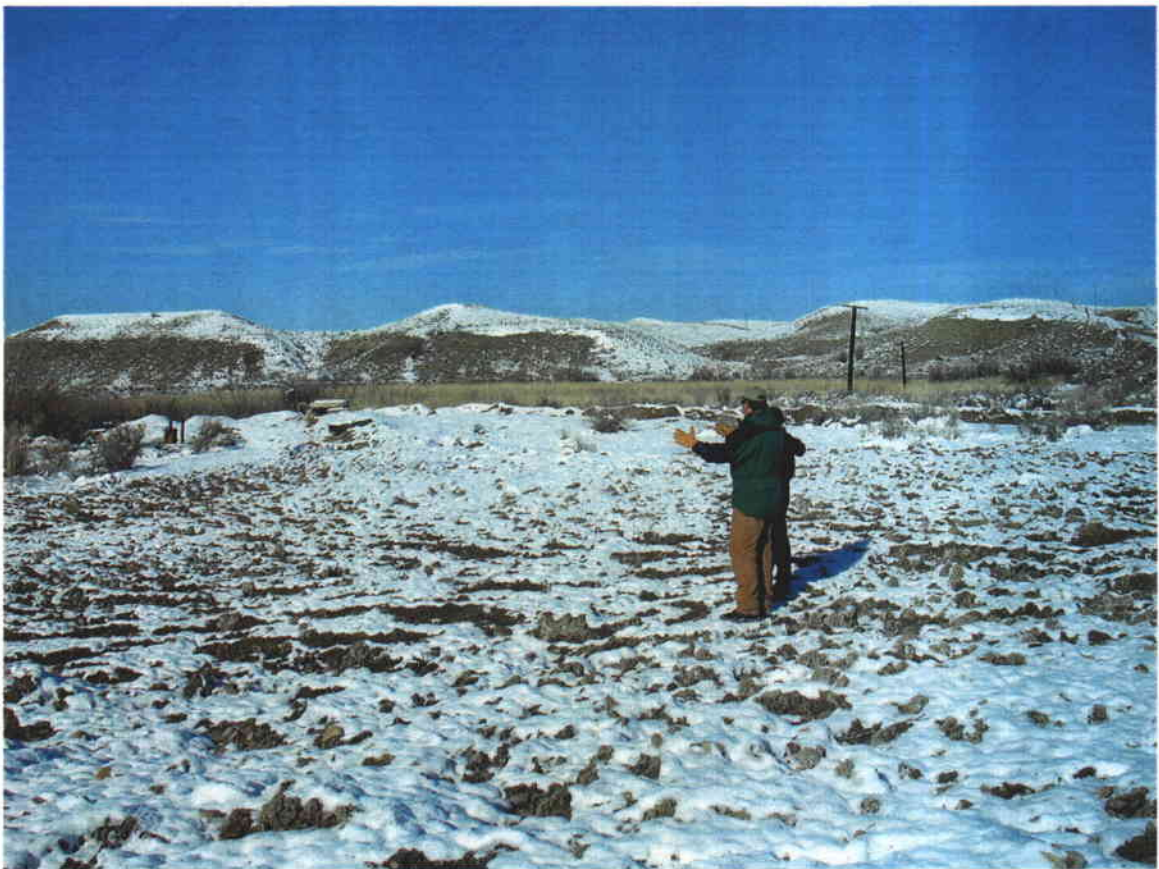
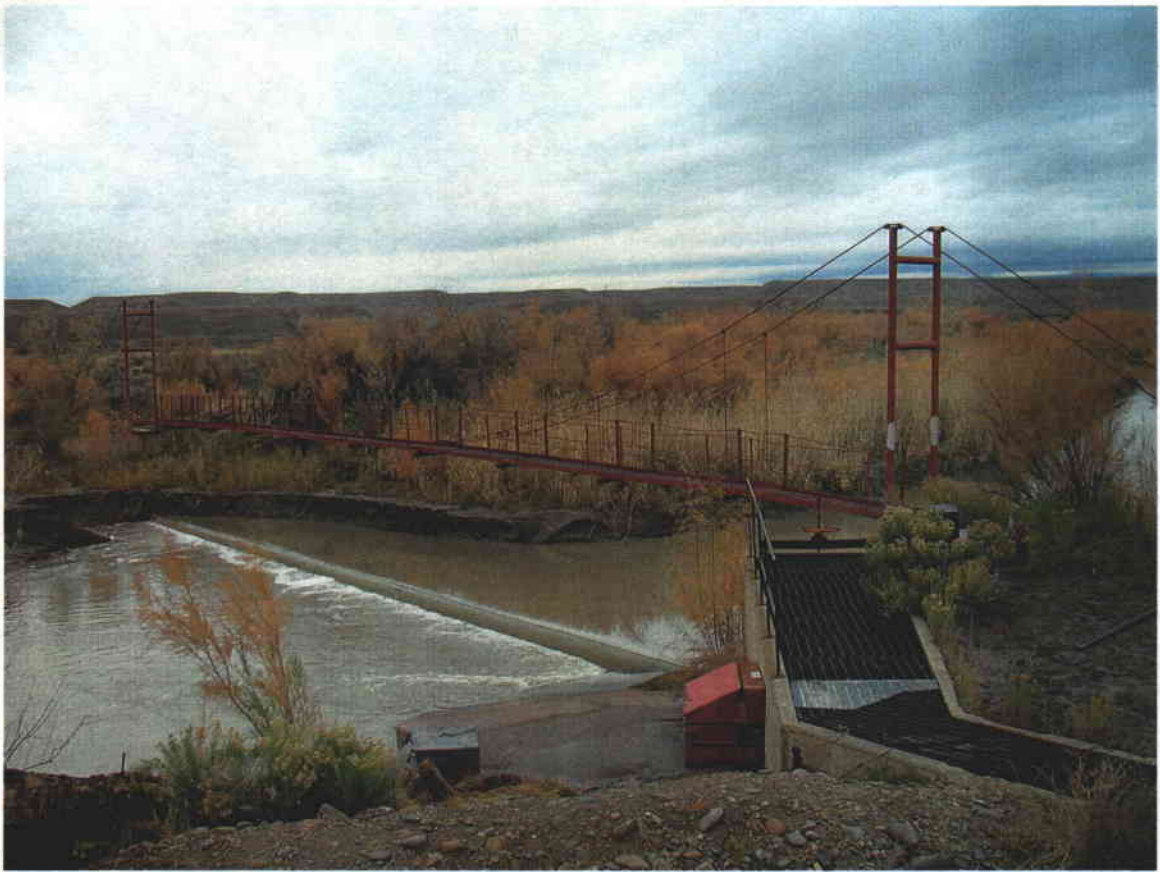
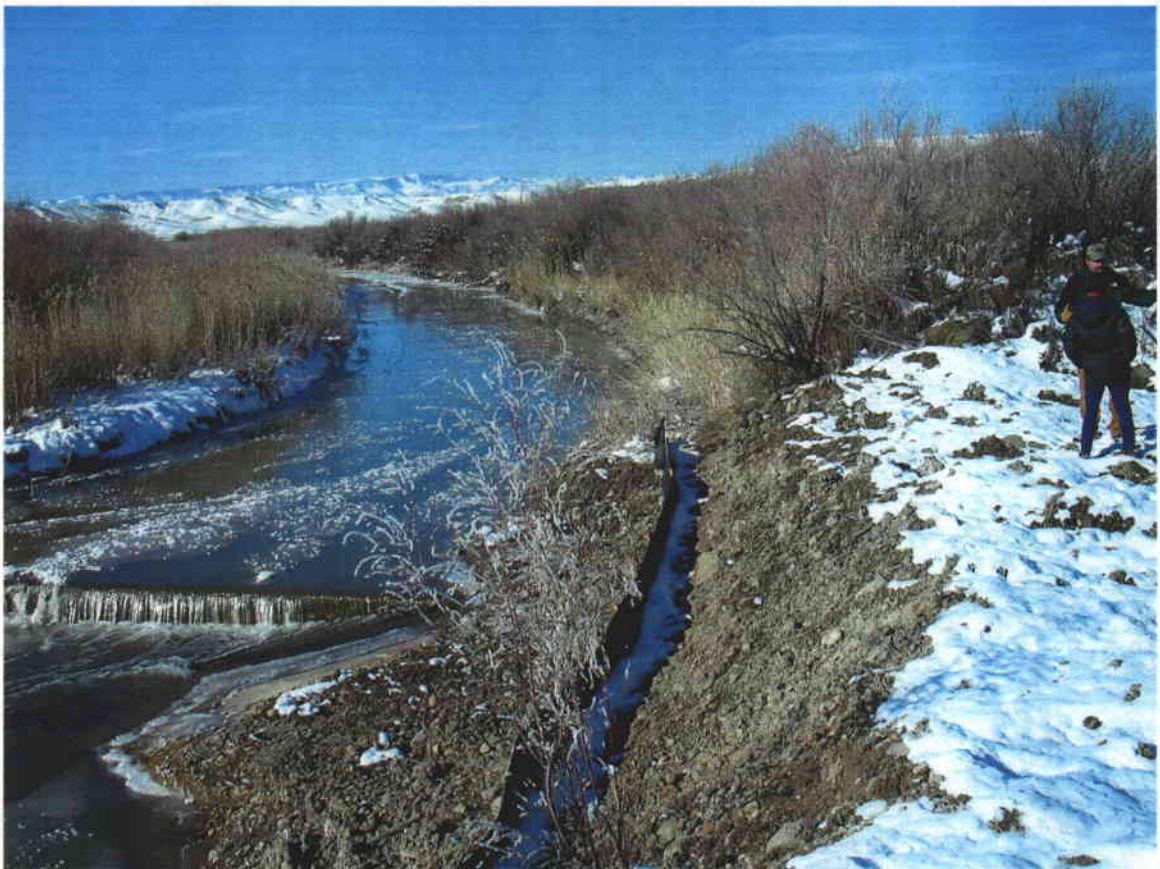
Grading was recently completed on the operations pad and slopes west of the lower slurry pond and at the river pump house. Both sites blend well with the surroundings. The land was left rough and is ready for seeding. At the time of the inspection, the ground was frozen and covered with an inch or two of snow. No additional repairs are necessary at this time. The soils along the reclaimed river bank were mixed with 8 inch minus rock. The soils in this area were sampled prior to 1983 by U.S. Steel Corp. The results of the 0-12 inch sample labeled 4A are found in Table 2-4 of Section 2.22 of the MRP. Sampled soils were of sandy texture, pH of 8.9 and with low Electrical Conductivity. Magnesium was the dominant cation. Photos M:\FILES\COAL\PERMITS\007\0012\IMAGES\10272004\DSCN0290, DSCB0296, M:\FILES\COAL\PERMITS\007\0012\IMAGES\11302004\DSCN0342, and DSCN0342 provide illustrations of before and after reclamation activities of the pumphouse, bridge, and diversion ditch structures, respectively.
